FM Homecheck, Inc.

SUMMARY REPORT

Client: Client Name removed
Realtor: Alan Schorr, Alan Schorr Real Estate, Inc.
Inspection Address: 2757 Stevens St. , Philadelphia, PA 19149
Inspection Date: 4/30/2014 Start: 1:00 pm End: 2:00 pm
Inspected by: Francis M. McGovern, Jr.

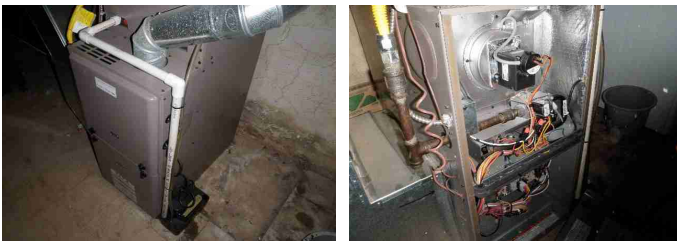
The furnace is functional. We were able to verify heat throughout the home. This unit appears to be 4 years old with a normal life expectancy of 25 years.

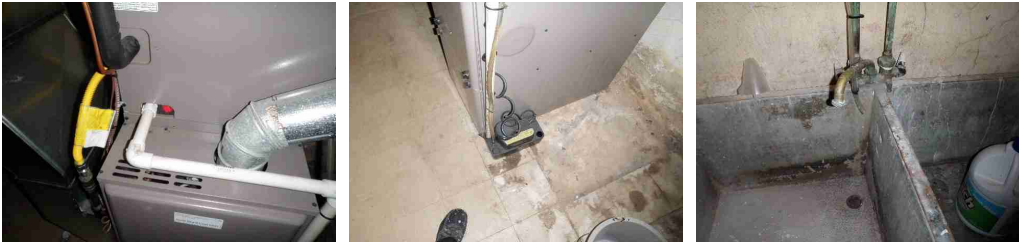
Laundry sink - Continued

The condensate drainpipe discharges into the basement laundry sink. This will need to be checked and cleaned regularly. Consult HVAC contractor to check condensate pump, tube and drainage.

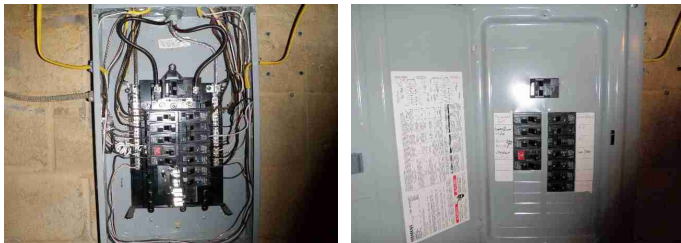
The visible portions of the wiring has no visible deficiencies.

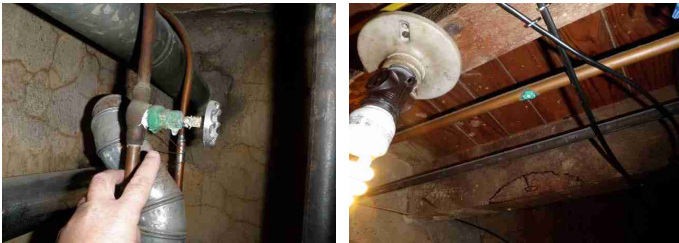
Recommend further monitoring if not replacement of the corroded valves and or pipes at this home. The corroded pipes/valves may burst or leak without warning. The corrosion can come from a variety of reasons such as a previous leak or spill on the pipe; sloppy soldering, leftover flux will turn green; electrolysis, which is when two dissimilar metals like copper touching galvanized pipes/ductwork or other copper piping. Leaking at water heater shutoff.

- Recommend further monitoring if not replacement of the corroded valves and or pipes at this home. The corroded pipes/valves may burst or leak without warning. The corrosion can come from a variety of reasons such as a previous leak or spill on the pipe; sloppy soldering, leftover flux will turn green; electrolysis, which is when two dissimilar metals like copper touching galvanized pipes/ductwork or other copper piping.
Leaking at water heater shutoff.

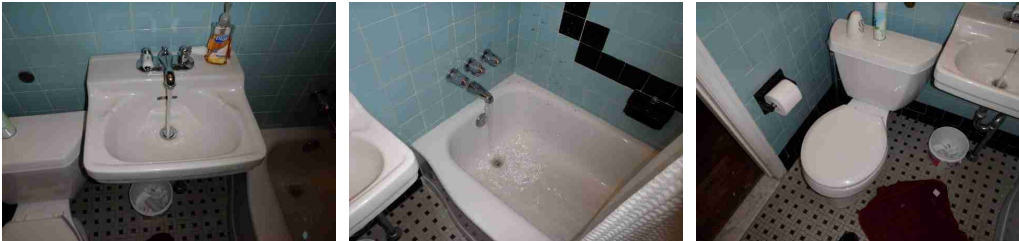
The sink and its components are functional.

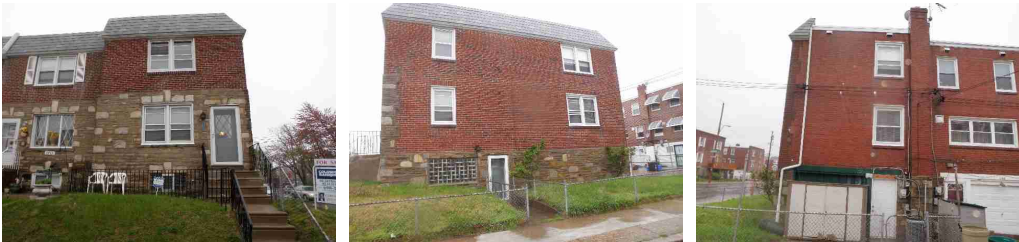
This properties exterior walls are covered with what appears to be brick and stone. This is a very durable wall covering that can last up to 100 years with very little maintenance. Brick pointing and minor patching between bricks or stones will be necessary throughout the life of this wall covering.

Some vinyl siding also at the front of the home.

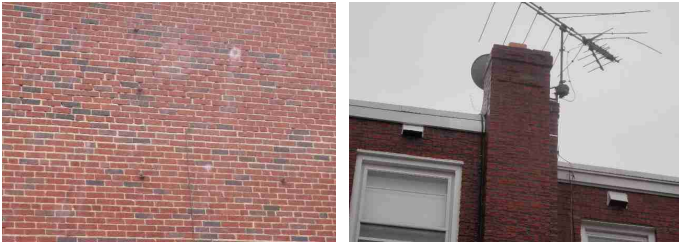
Needs pointing now - *Continued*

Recommend consulting a masonry contractor for immediate brick pointing or filling in the eroded and missing mortar between bricks/stones at this home. This home needs immediate pointing at the following locations:

Side of home and at the top of the chimney.

- Recommend consulting a masonry contractor for immediate brick pointing or filling in the eroded and missing mortar between bricks/stones at this home. This home needs immediate pointing at the following locations:
Side of home and at the top of the chimney.

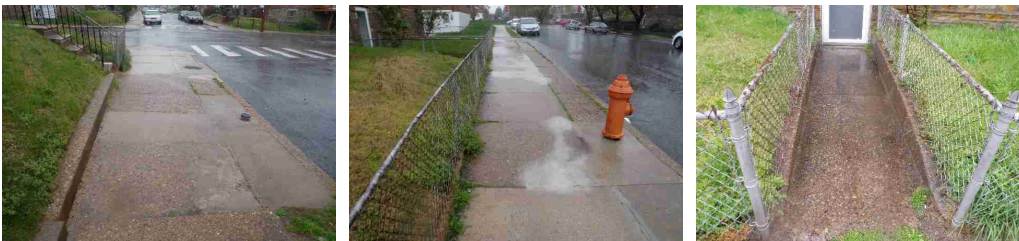
The walkways are in acceptable condition at the exterior of this property. There are some small spaces between the blocks in the walkways and some minor cracks that need caulking to keep water out. This will be part of the ongoing maintenance of this material, caulk all cracks before they become big cracks!

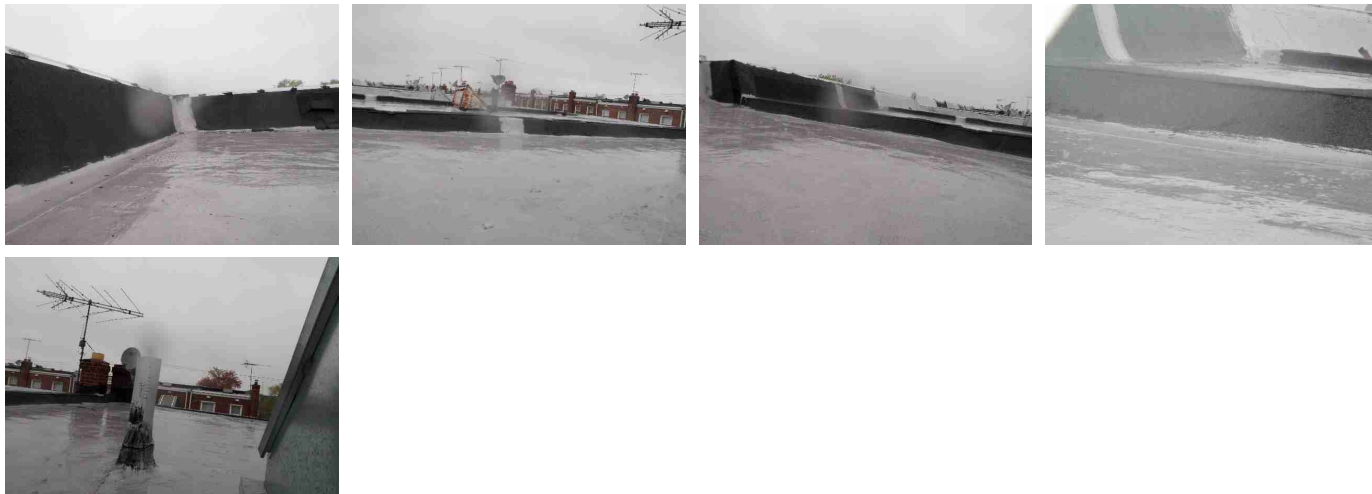
This roof is in poor condition. The parapet walls have holes in them, and some of these holes have been poorly patched. Recommend consulting a roofer for immediate replacement of this roof. This roof has a very high chance of leakage. This roof is old and brittle, poorly coated today, aluminum fiber paint is worn off in some locations. The idiot who patched the side parapet wall should provide some type of warranty for the patch work completed. Without a guarantee for this patching I strongly suggest replacing this roof now.

- This roof is in poor condition. The parapet walls have holes in them, and some of these holes have been poorly patched. Recommend consulting a roofer for immediate replacement of this roof. This roof has a very high chance of leakage. This roof is old and brittle, poorly coated today, aluminum fiber paint is worn off in some locations.
The idiot who patched the side parapet wall should provide some type of warranty for the
